Site Visit Report: SV-2019-12-13

## Trans Mountain Expansion Project – Westridge Marine Terminal (WMT) Visit

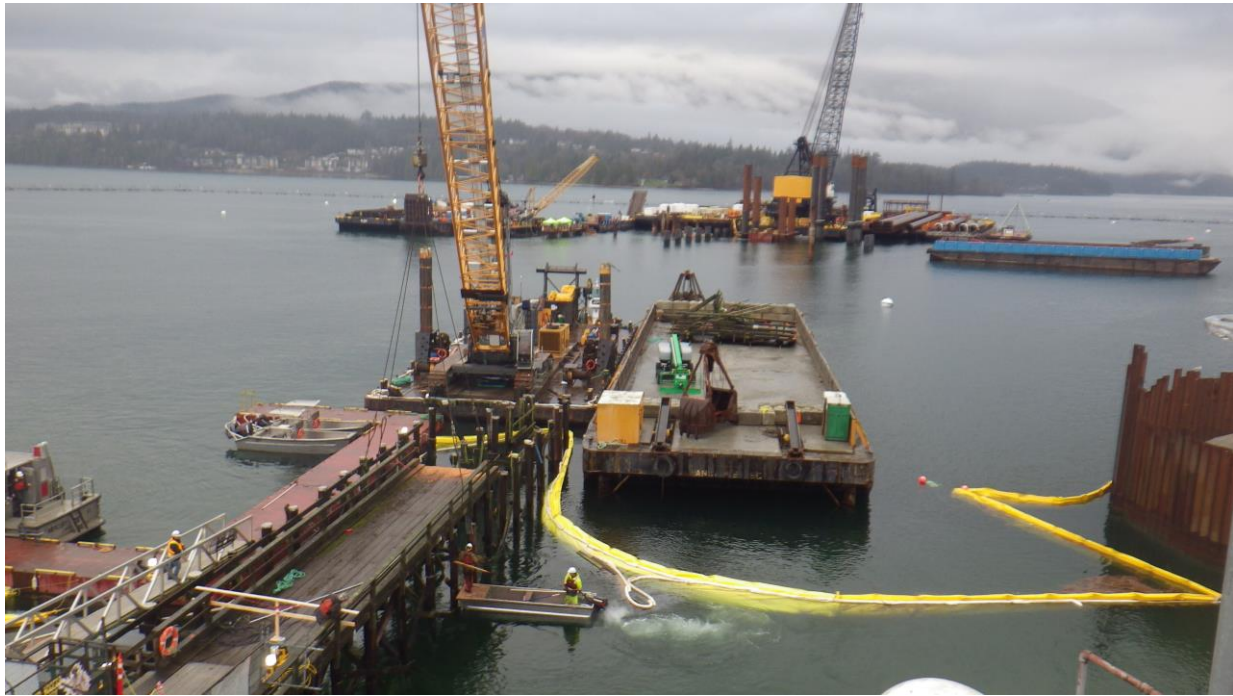
A yellow turbidity curtain and a white sorbent boom were placed around the utility dock and appeared to be effective at isolating the area and collecting saw dust, wood debris, and creosote released during the utility dock's demolition.
Action Items
N/A
<b>Pump Intake Screening</b>

**Photo 1. Yellow turbidity curtain and white sorbent boom installed around utility dock during dock demolition activities conducted by JJM.**

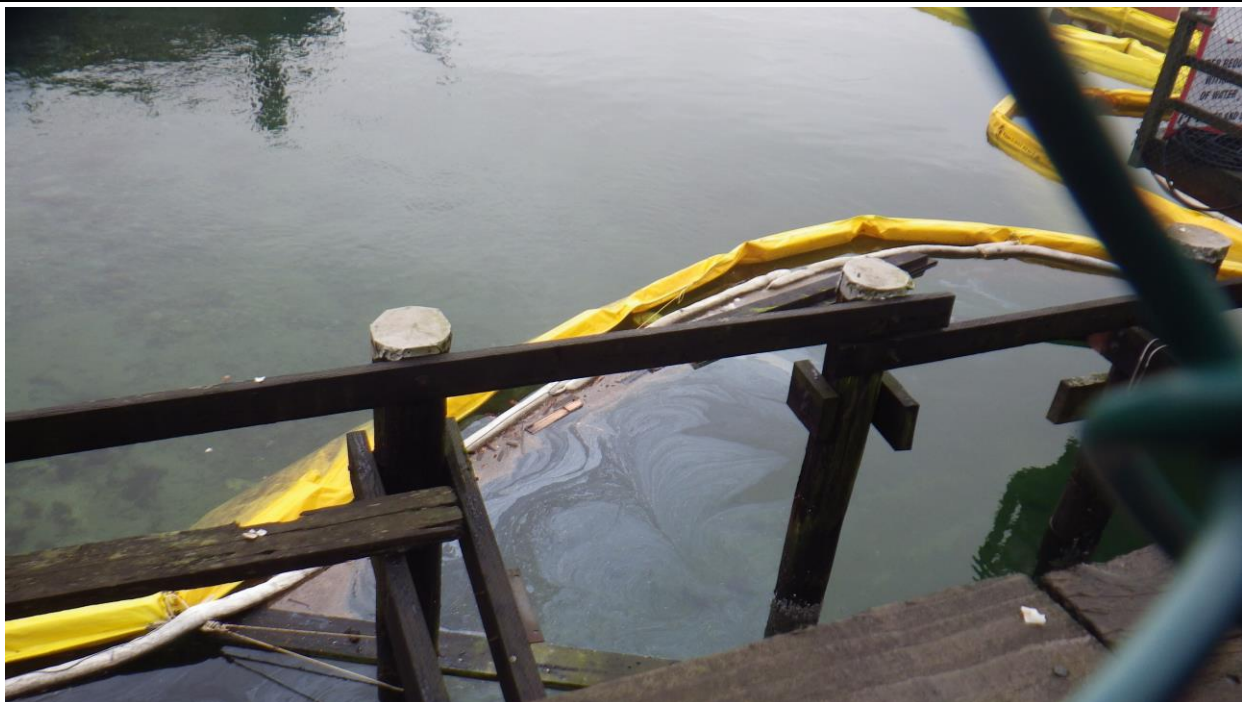
**Photo 2. Yellow turbidity curtain and sorbent boom containing saw dust, wood debris, and creosote released during demolition of the utility dock. Any remaining debris is skimmed off the surface of the water at the end of each day.**

- Trans Mountain to send DFO the information on pile size, hammer, etc. that was requested from TM by the VFPA.
- Trans Mountain to install an additional spill boom along the shoreline near the dock demolition work as requested by the IAMC Indigenous Monitor.
- Trans Mountain to re-install the sediment fence near the deep soil mixing test hole to help prevent runoff from entering the marine environment.

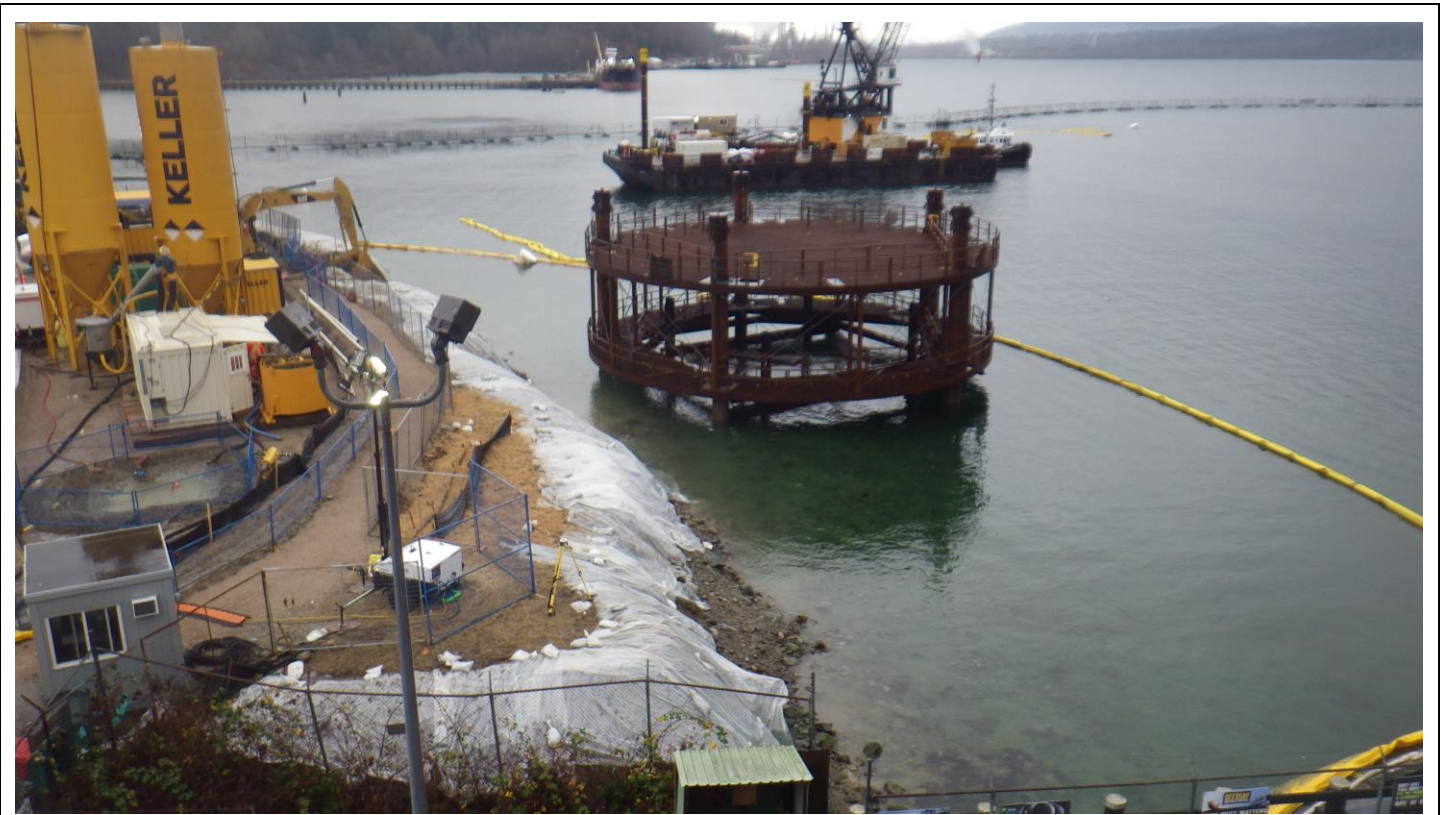
29. During in-water excavation of rip rap, conduct water quality monitoring (WQM) as per the Water Quality Management Plan during Rip Rap Removal (Appendix H of this EPP). Conduct WQM to assess the effectiveness of the turbidity curtain and modify turbidity curtain deployment, if required.
<input type="checkbox"/> Compliant <input type="checkbox"/> Non-compliant <input type="checkbox"/> Not observed/unknown <input checked="" type="checkbox"/> Not applicable
<i>Westridge Marine Terminal Sediment and Erosion Control Plan Commitments</i>
The in-water sediment curtain will remain intact during Foreshore construction activities to ensure sediment laden water is not discharged into Burrard inlet.
<input checked="" type="checkbox"/> Compliant <input type="checkbox"/> Non-compliant <input type="checkbox"/> Not observed/unknown <input type="checkbox"/> Not applicable
<b>Comments</b>
The turbidity curtain remains in place around the sheet pile cells and attaches to the foreshore. A turbidity curtain, and sorbent boom were in place around the utility dock during its demolition. Another turbidity curtain was in place around the works associated with the temporary flexi-float dock.

**Photo 3. Yellow turbidity curtain around works associated with installation of temporary flexi-float dock.**

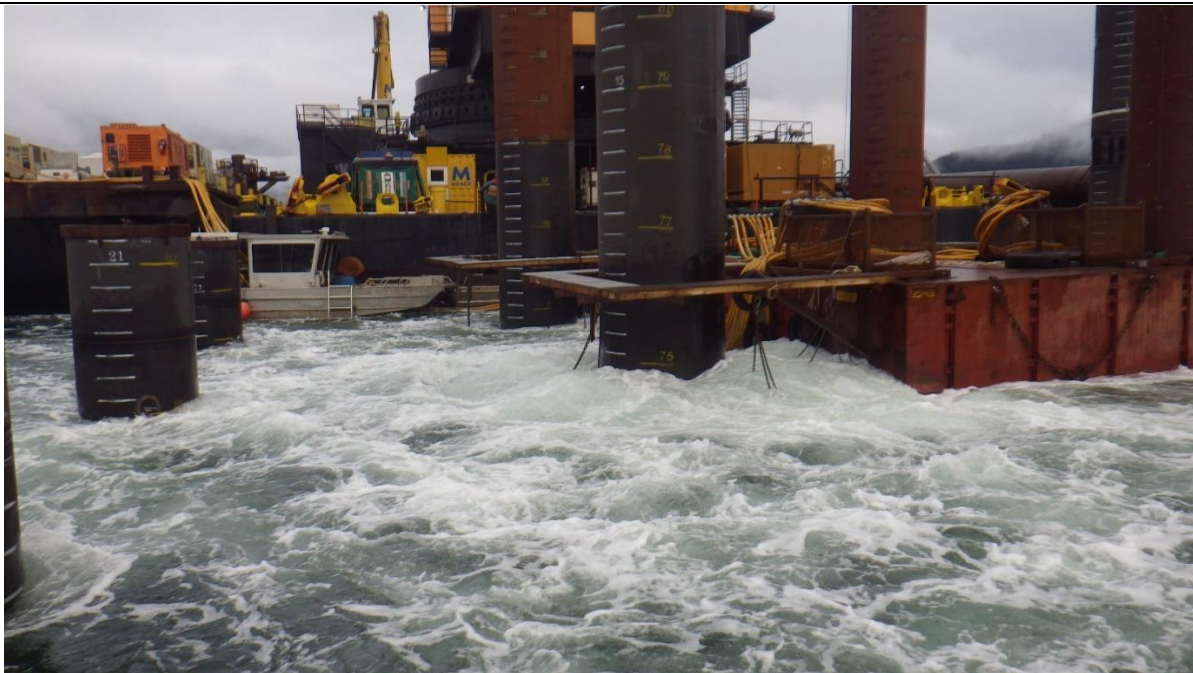
<p>1100-1130</p>	<p>Boat trip:</p> <ul style="list-style-type: none"> <li>-Observed bubble curtains in action (Photo 4). The TM EI indicated that a dive crew was on site and using drop cameras to capture footage of the curtains underwater. This was being done as part of TM's preliminary investigation associated with the recent fish kill events.</li> </ul>
<p>1130-1200</p>	<p>Walk along foreshore:</p> <ul style="list-style-type: none"> <li>-Observed installation of three layers of sediment and erosion control measures (lock blocks, a berm, and a sediment fence) along the foreshore to capture potential run-off during deep soil mixing activities. The TM EI indicated that the sediment fence near the deep soil mixing test hole will be re-installed by TM as it was not keyed in properly. The lock blocks and berm appeared to be functioning as intended.</li> </ul>

**Photo 4. Activated bubble curtains, which are used to dampen underwater noise levels during impact pile driving, being tested in the absence of impact hammer pile driving.**
